Manhole Inspection Summary

Manhole # S07OO1043MH

Insp Date: **7/16/09 11:17 AM**

Location Address: **BEHIND 3320 GARRISON AVE**

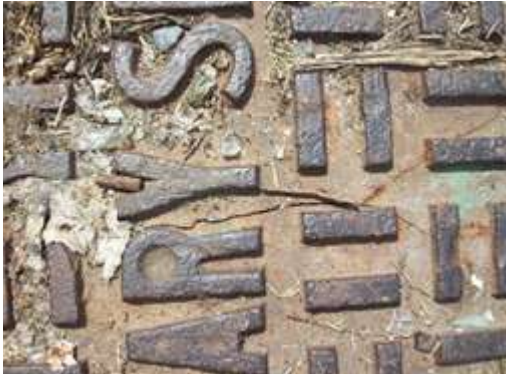
Defect 2

Condition: **Cracked**

CRACKRD LID

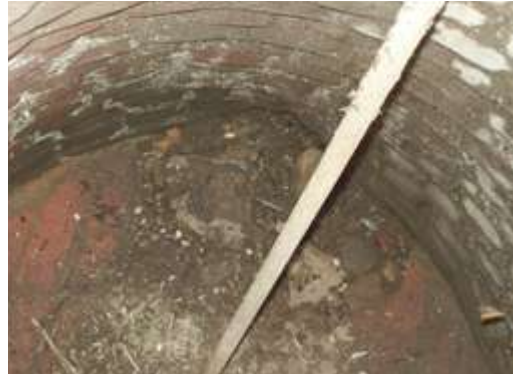
Defect 4

DEBRIS ON CHANNEL

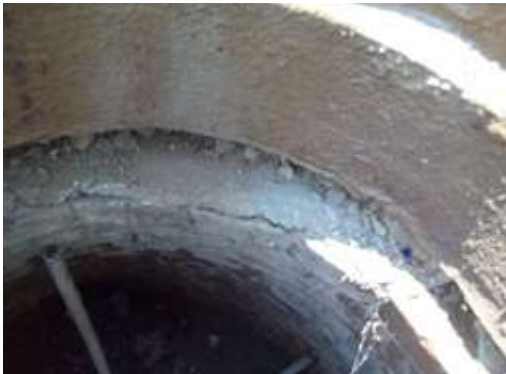
Defect 3

Offset: **2** (in.)

FRAME OFFSET

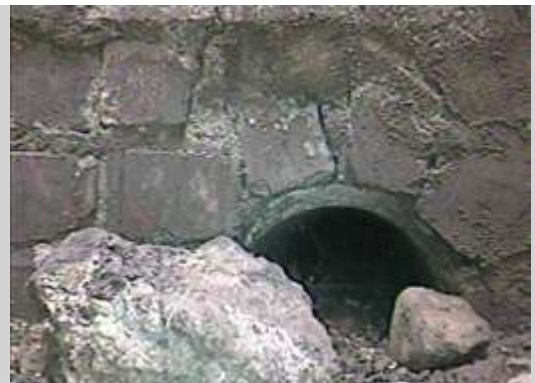
12 O'Clock Outflow

8 in. Circular Gravity Sewer
Pipe Out @ 12 O'Clock

Infiltration: **None** Pipe Seal Cond: **Sound**
